**PHASE IB
ARCHEOLOGICAL FIELD RECONNAISSANCE**

**FDR LIBRARY AND MUSEUM IMPROVEMENT PROJECT
HOME OF FRANKLIN ROOSEVELT NATIONAL HISTORIC SITE
NATIONAL PARK SERVICE
AND
NATIONAL ARCHIVES AND RECORDS ADMINISTRATION
PROPERTY
4079 ALBANY POST ROAD
TOWN OF HYDE PARK, DUTCHESS COUNTY, NEW YORK**

**OPRHP # 09PR04334
HAA 4213-21**

Date of Report: November 2009

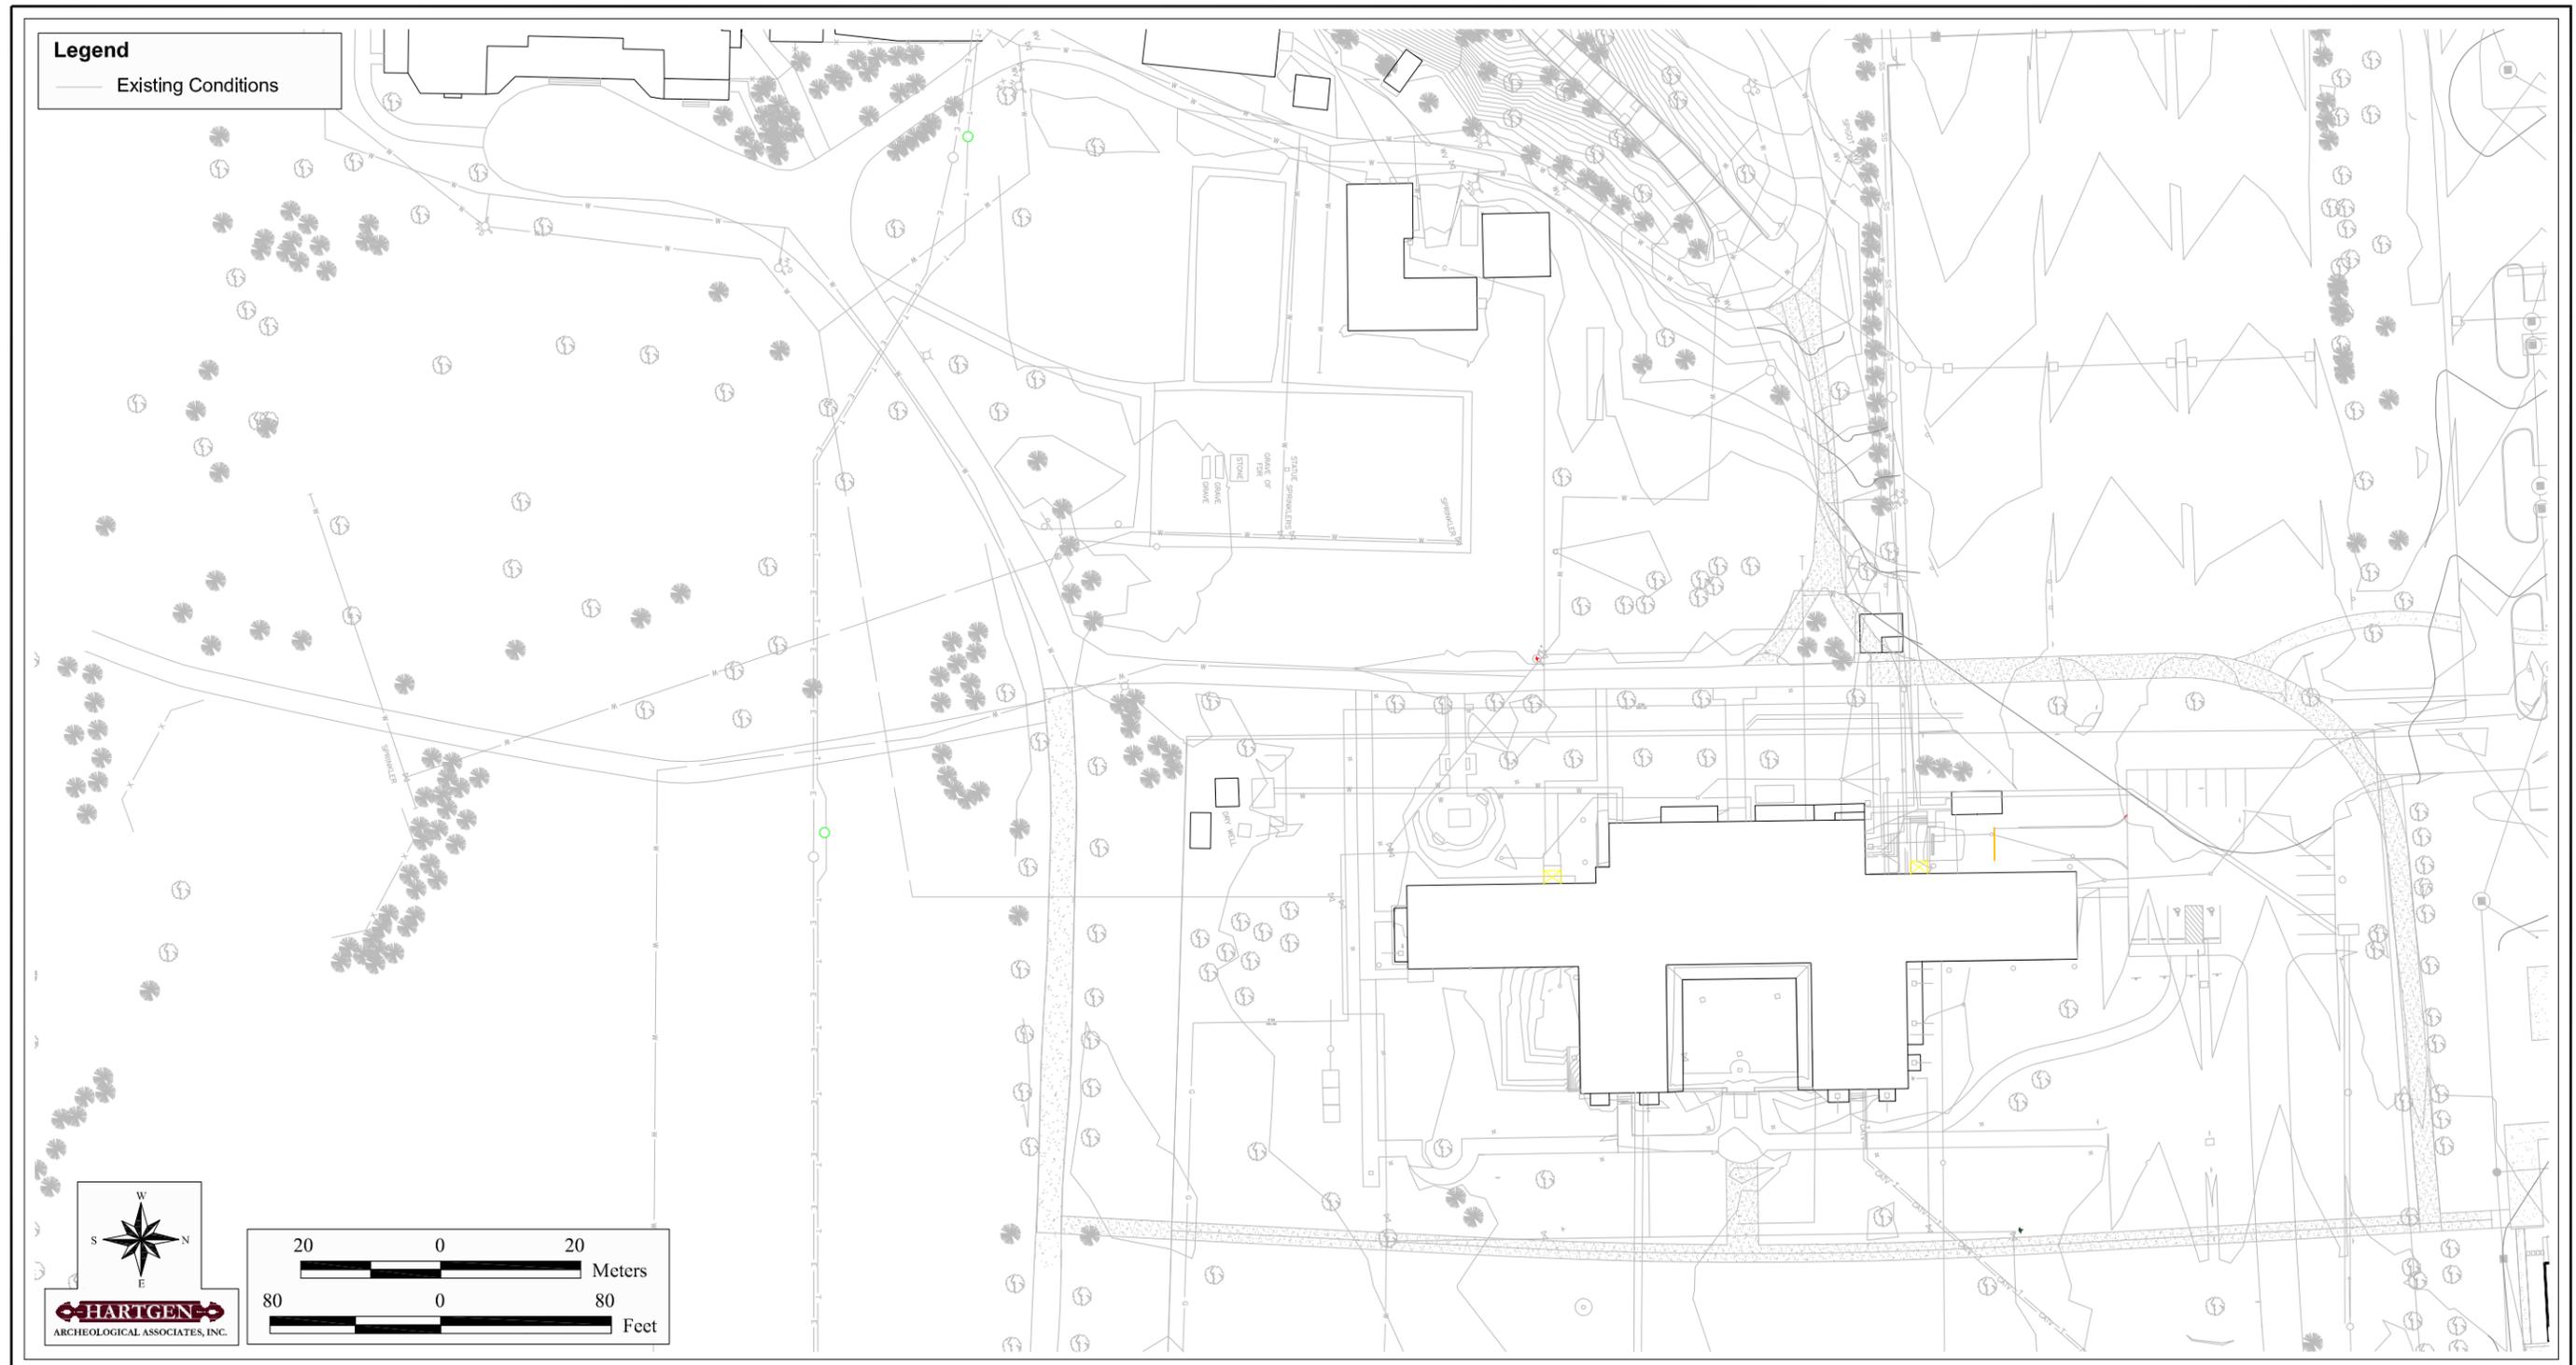
Existing Conditions (2009 Einhorn Yaffee Prescott, A&E Project Map)

Map 2 and Appendix 1 depicts the existing conditions immediately around the library. Map 3 details the archeological results. Map 4a depicts the proposed impacts to the landscape and exiting paths and road. Map 4b provides the proposed below ground impacts and trenches, relative to the archeological tests. Map 4c details the initial plans for the storm water outlet, although these are now subject to change based upon information from the NPS and the results of the archeological study.

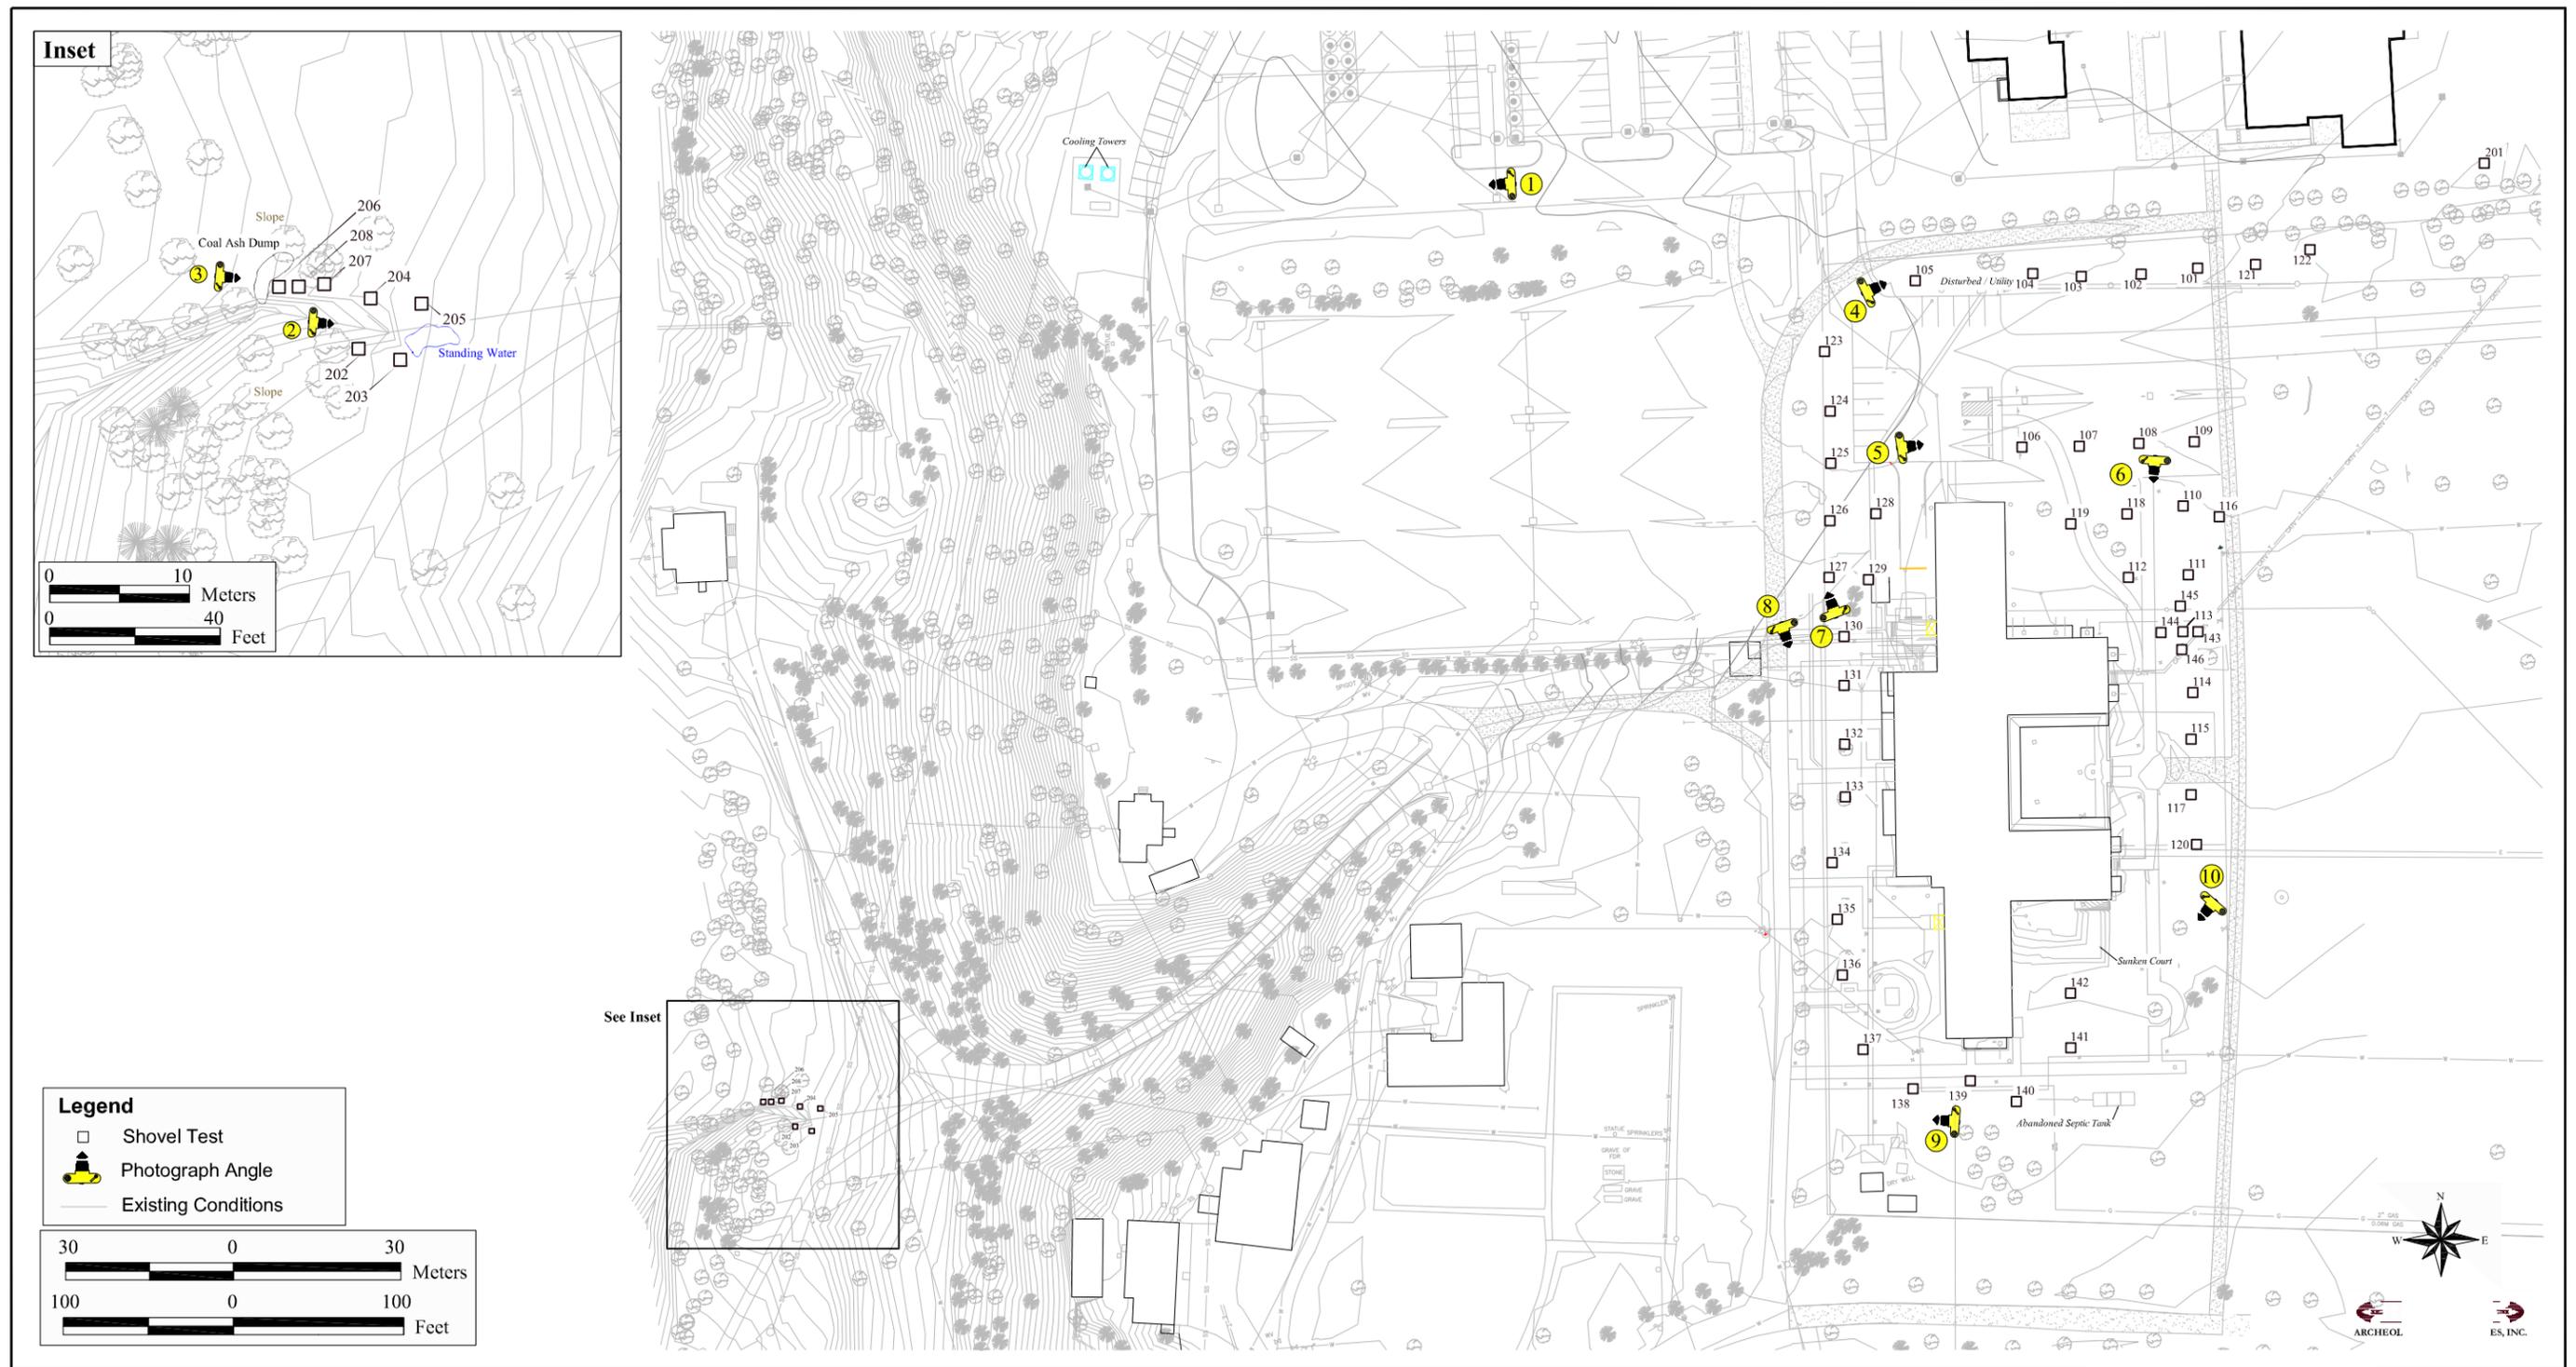
Map 3

Archeological Results (2009 Einhorn Yaffee Prescott, A&E Project Map)

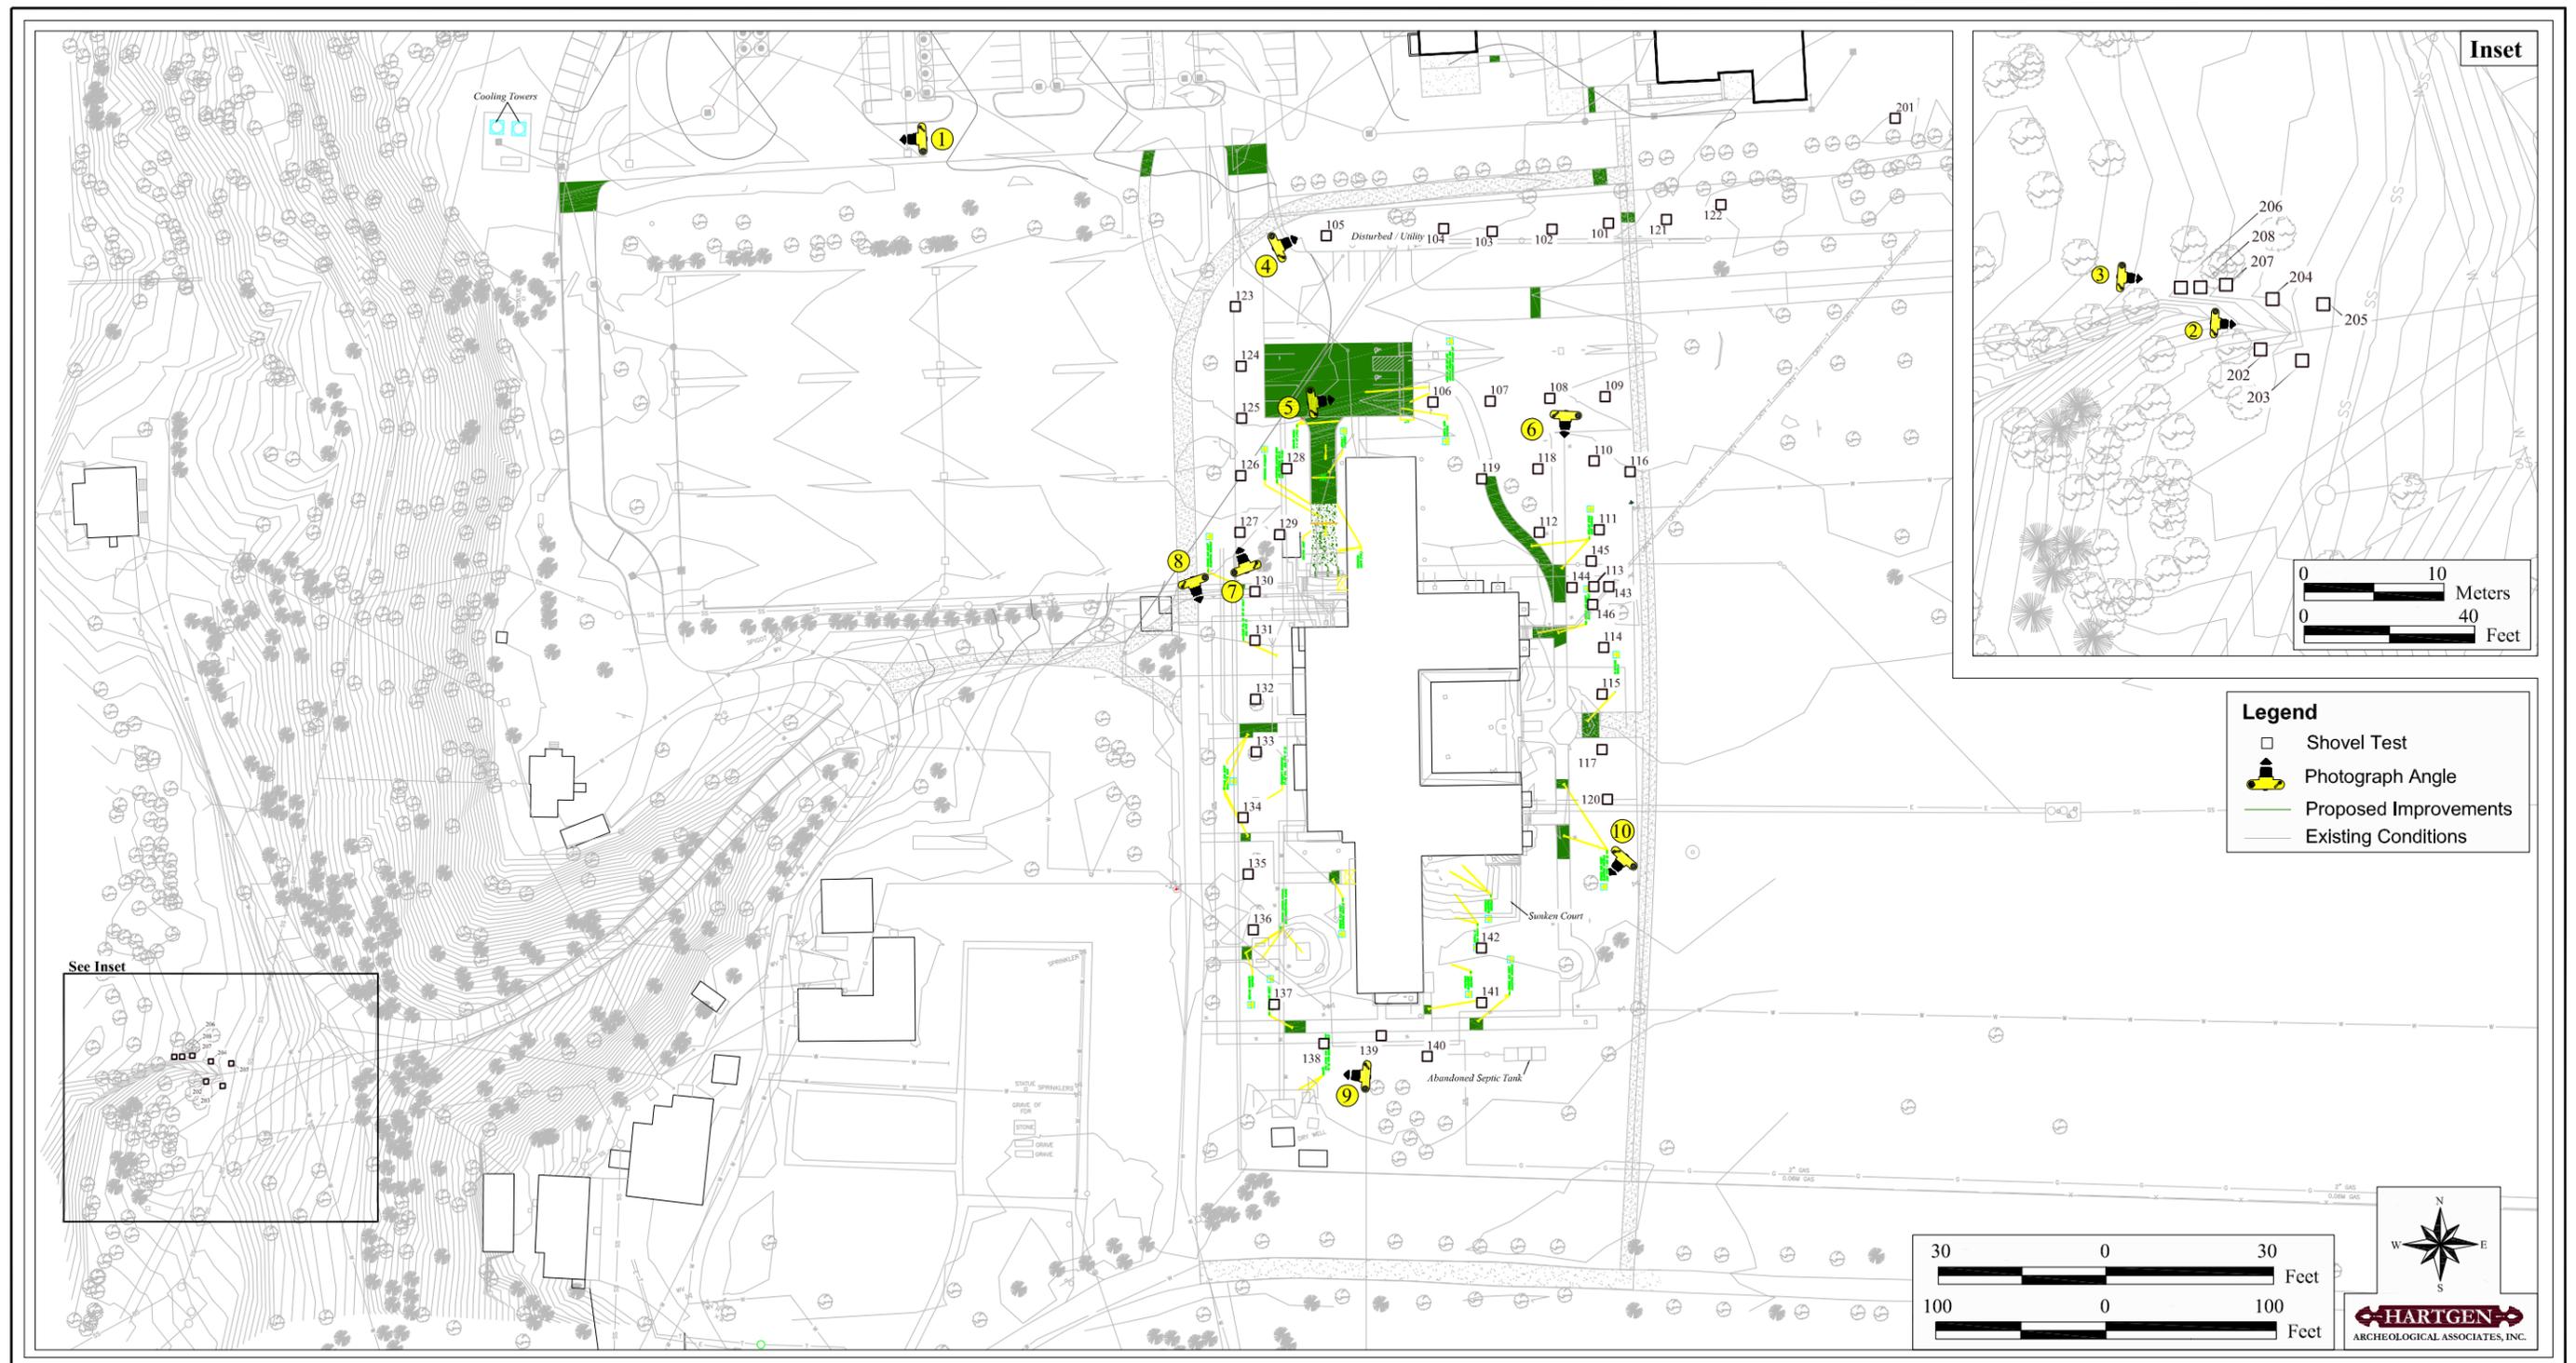
Map 4a

Proposed Improvements (2009 Einhorn Yaffee Prescott, A&E Project Map)

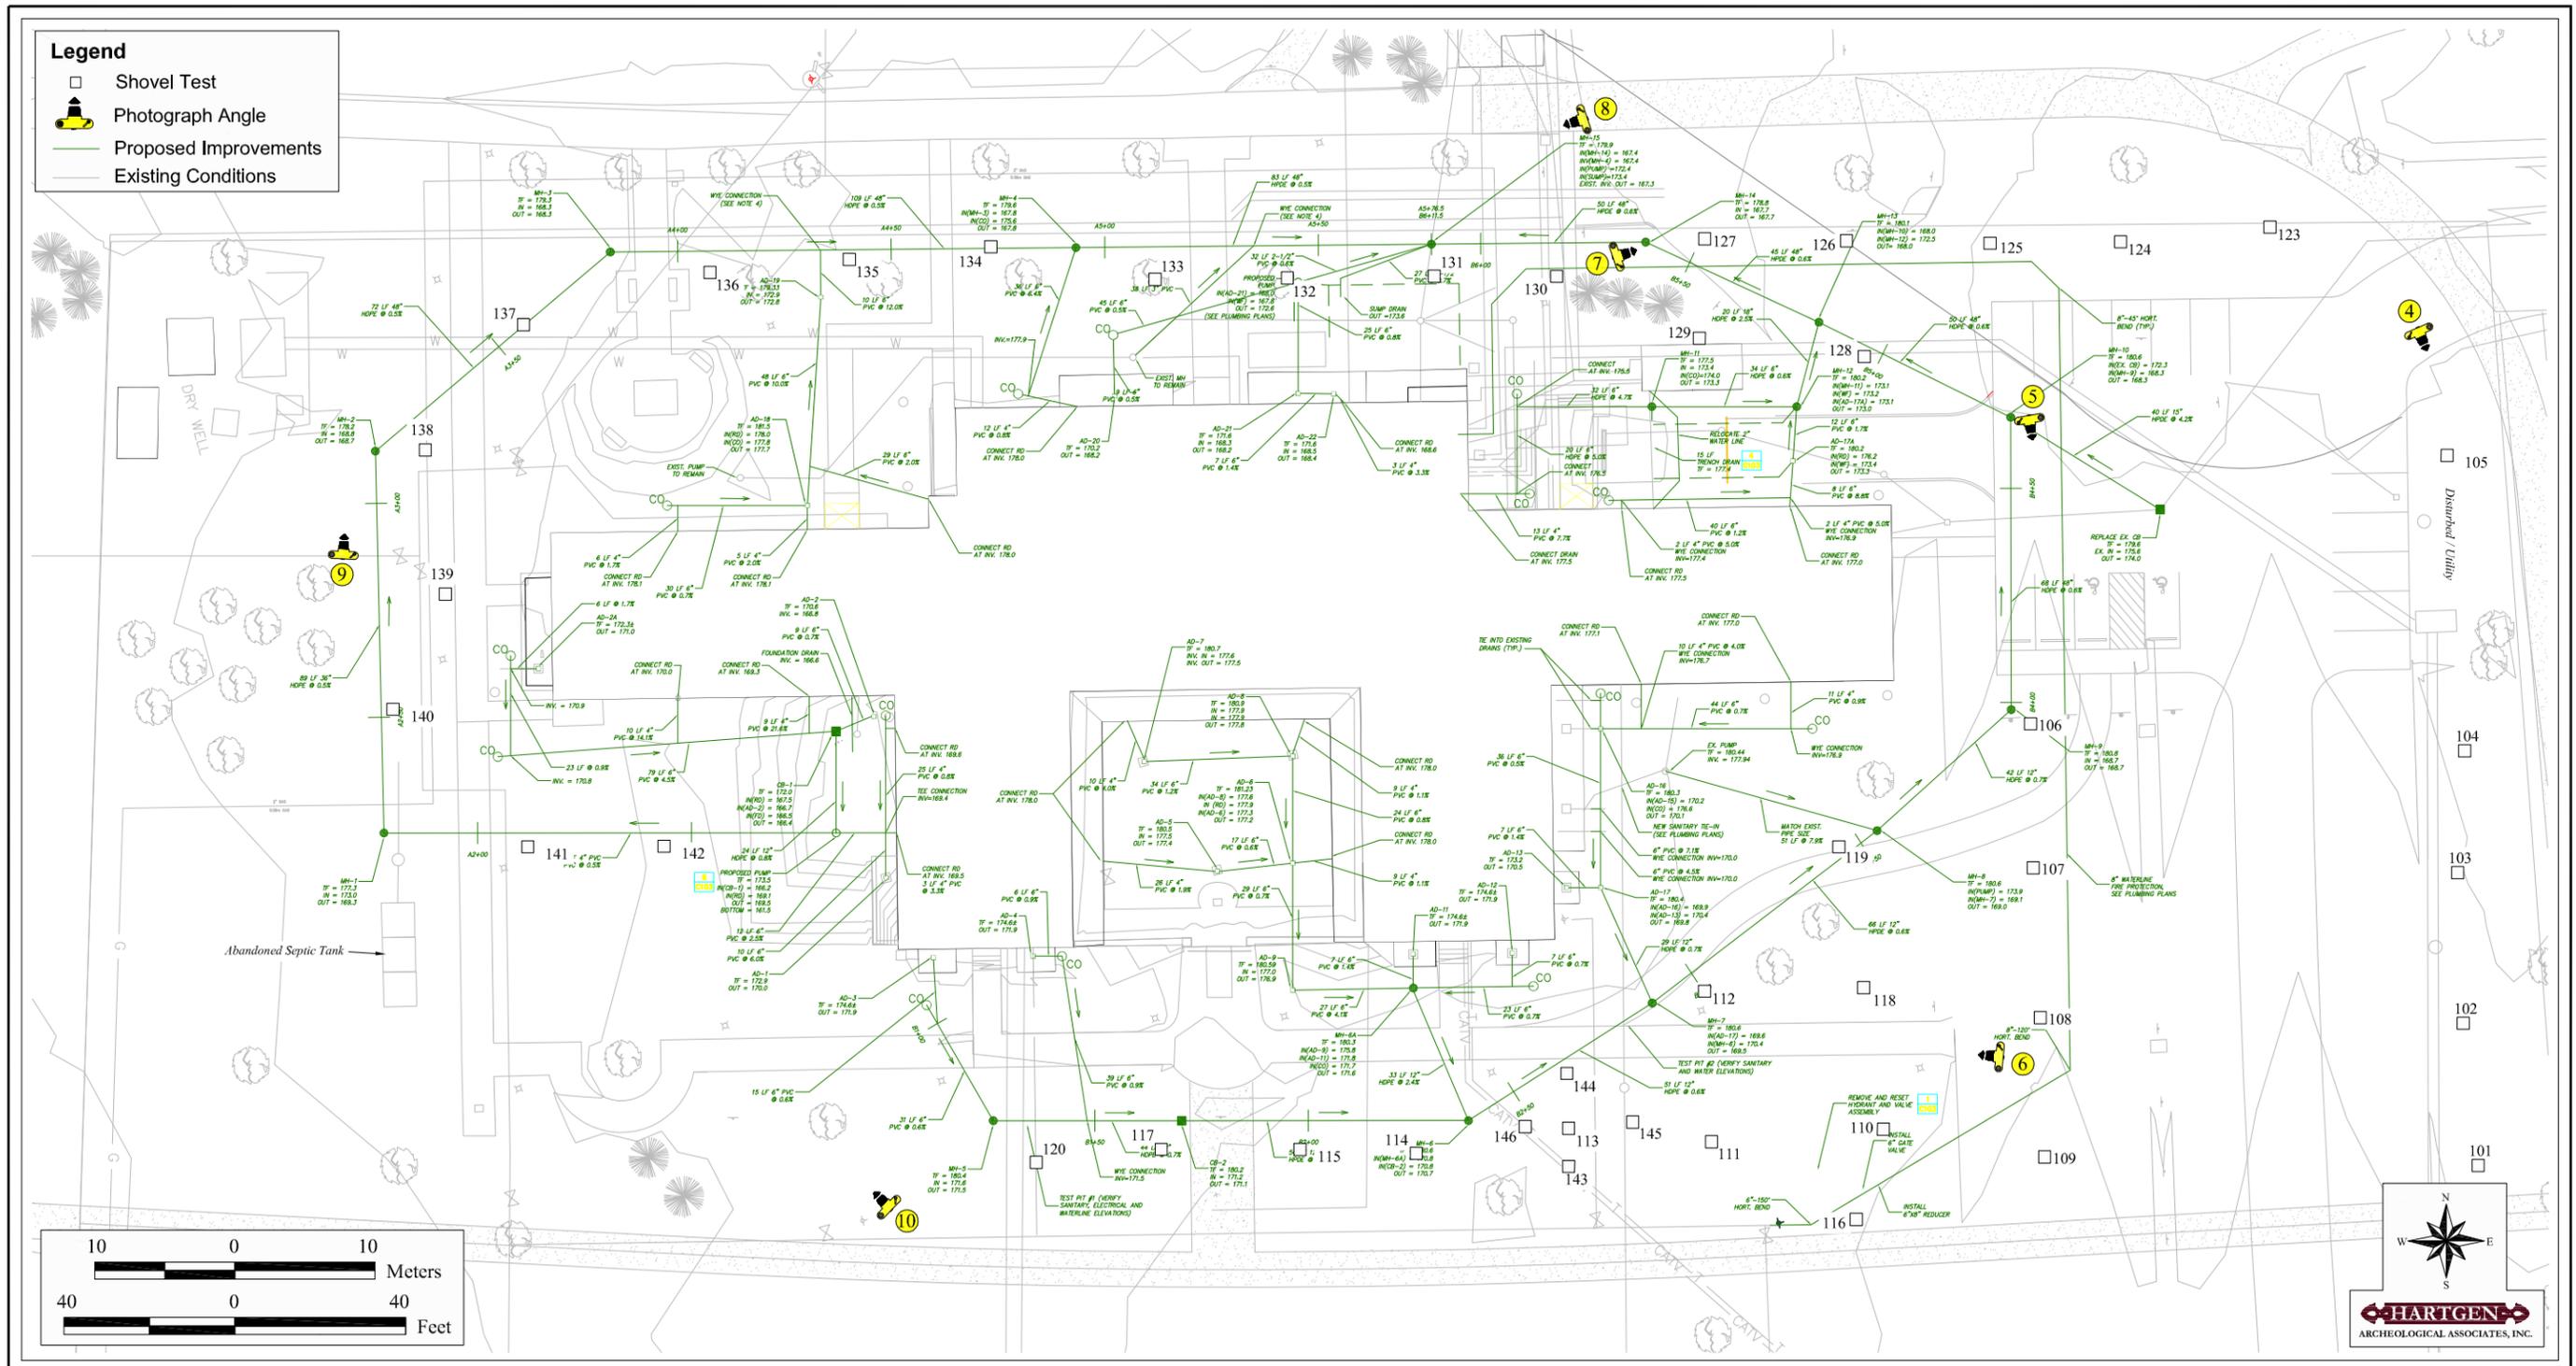
Map 4b

Proposed Improvements (2009 Einhorn Yaffee Prescott, A&E Project Map)

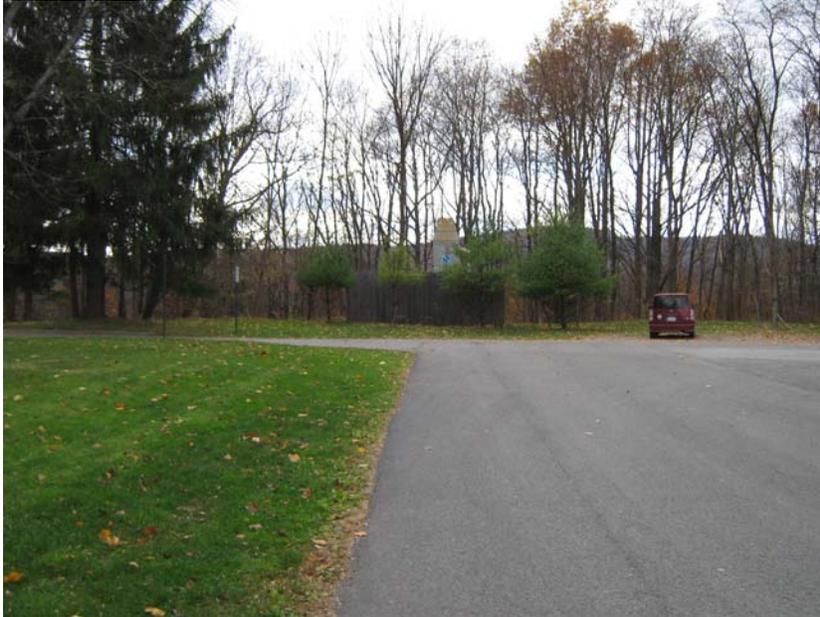
Photo 1. View west of the existing cooling tower for the Wallace Center. The library will abandon its existing cooling tower and utilize the visitor's center. The area along the southern portion of the parking lot where the proposed heating and cooling lines will be buried has been previously tested (see Figure 3).

By 1964, a cooling tower had been erected on the southwest corner of the main library building. This was subsequently removed and the concrete pad upon which it was built was left in place until the construction of the north and south wings several years later. Several new walking paths were proposed around the gate house in the rear of the library. In the 1967 drawings, the gate house was labeled as pump house, suggesting that buried water lines had also been installed in the area to assist in diverting water from around the foundation of the library. Water appears to have a constant problem for the foundation since construction. The pump house was enlarged from its original square shape to one with a rectangular plan.

The sections of the proposed project on NPS land, on the former Bellefield property to the north are located in areas that have been previously tested, and/or disturbed in the instance of the existing cooling towers at the west end of the parking lot. At the storm water outflow to the west of the library, seven tests were excavated. None of the tests identified archeological deposits or features of interest. However, a coal ash dump was noted downstream and immediately west of Test 206. This test helped to confirm its eastern extent as virtually no coal ash was found in the test.

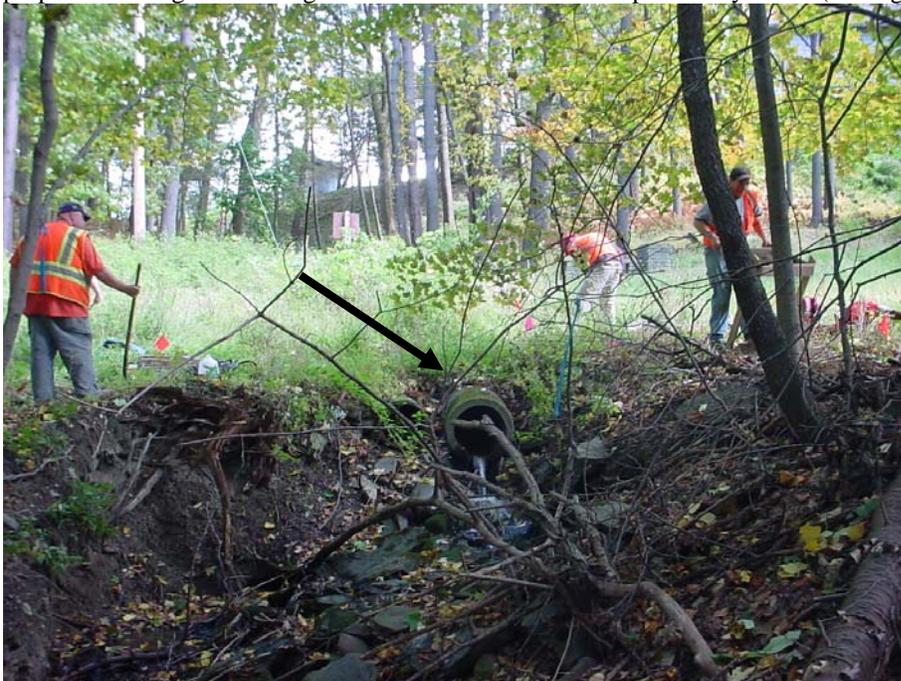
Photo 2. The storm water outlet location on the NPS property to the west of the library. Seven tests (202-208) were excavated around the outlet. The stream banks are being eroded by the flow of water. The area immediately adjacent to the outlet has been disturbed by the installation of several generations of drainage pipes (indicated by arrow).

The proposed drainage area is located on NPS land down slope of the library approximately 200 meters (656 feet) to the west (Map 4c). A series of older drainage outlets have been built in the same location over the years (Photo 2). The outlet receives water pumped from the pump house at the rear of the library from around the foundation and issues it into a small stream that flows westward to the Hudson River. The project plans include using stone rip-rap about 1.5 feet deep to stabilize the eroding bank along the stream immediately downs stream of the outlet. A settling pool will slow the flow of the water which will then proceed through an eight-inch, 17-foot long pipe. In all the impacts will be approximately 37 feet (11 m) long by 12.5 feet (4 m) wide in this area.

Standing water was noted immediately above (east) of the existing outlet. Much of the area has been disturbed by the construction of two separate drain pipes (one of which is no longer functional). Four tests were excavated on the level portions of the stream around the existing drain outlet. Final construction plans were not available to the archeologists at the time of the excavations. The placement of the shovel tests were aided by the NPS Chief of Area Services, Henry Van Brookhoven. According to Mr. Van Brookhoven since the trees in the area are considered to be an important component of the historic character of the area as they were part of planting

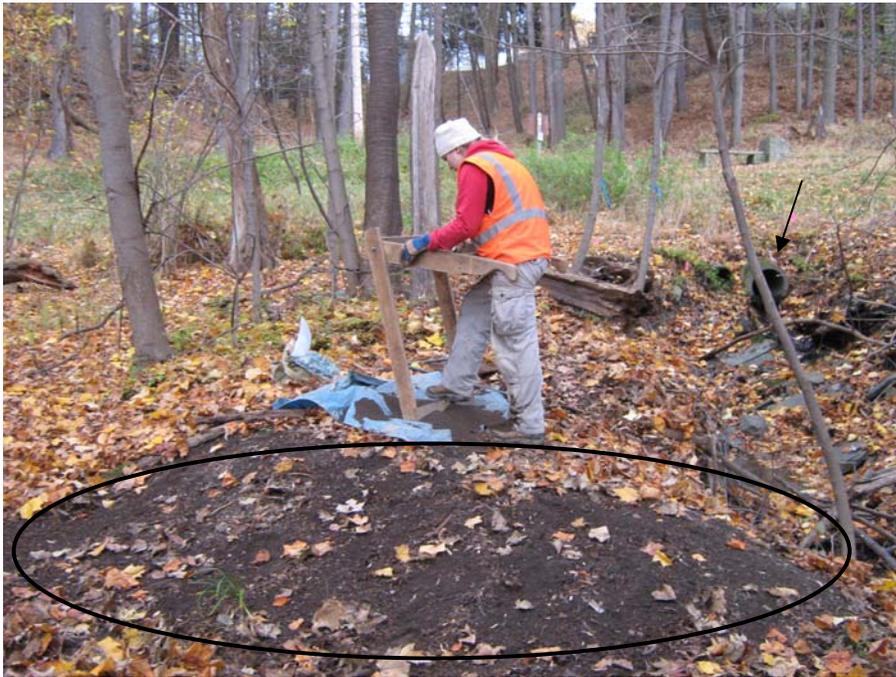
Photo 3. A 20th-century coal ash dump along side the small stream into which the storm water outlet (see arrow) from the library flows. Test 206 was excavated on the east side of the dump, and helped to delineate its eastern extent. Avoidance of the dump is recommended as it is likely a National Register eligible resource, associated with the Roosevelt family.

Prior to excavating the shovel tests, the exposed and eroding shore line was intensively surveyed for potential artifacts or features. No artifacts were observed in the soils; however, a deposit of coal ash was noted along the edge of the stream about 8.5 meters (28 feet) downstream of the outlet. No artifacts were observed in the coal ash, and no tests were conducted in this area as it appeared to be outside of the area of potential effects. The coal ash pile was about 6 meters (19.6 ft) long by about 3 meter (10 ft) wide (Photo 3).

Test 206 was excavated immediately adjacent to the east side of the coal ash dump. A few fragments of clinker were noted but no coal ash or other cultural material was located in this test. The test was excavated to a depth of 63 cm below the surface into a sterile subsoil of compact clayey silt, likely glacial lake deposits.

The coal ash dump deposit is part of a series of dumps noted in this area, called Dumps along River Road and the Duplex (ASMIS 00012.0001-4). Four separate loci have been identified to date, not including the current dump. There is no evidence that any of the dumps have been archeologically investigated, although there is evidence of looting occurring at some of the locations (PAL 2008: 53 and 60, Appendix B). The sites appear to have been found by park staff and reported in two separate reports by Dick Hsu (1973) and in Linda Towle, Dick Hsu, and Gerald Kelso (1990). These reports primarily deal with issues at the Duplex site and Bellefield property to the north and east. There has been no systematic effort to record all of the dumps in this area, and there is likely more to be discovered. On the Roosevelt and nearby Bellefield properties there have been other dump sites recorded including the Kirchner dump (ASMIS Resource HOFR 00010.000, Pump House Road (ASMIS Resources HOFR 00015.000), Bellefield Dump (ASMIS Resource HOFR 00002.003). None of these sites appear to have been recorded as an archeological site in the OPRHP site files, but are listed on the National Park Service's Archeological Sites Management Information System (ASMIS) as an archeological resource (as found in PAL 2008). A NYSOPRHP archeological site for the Dumps along River Road and the Duplex as been included in Appendix 4).

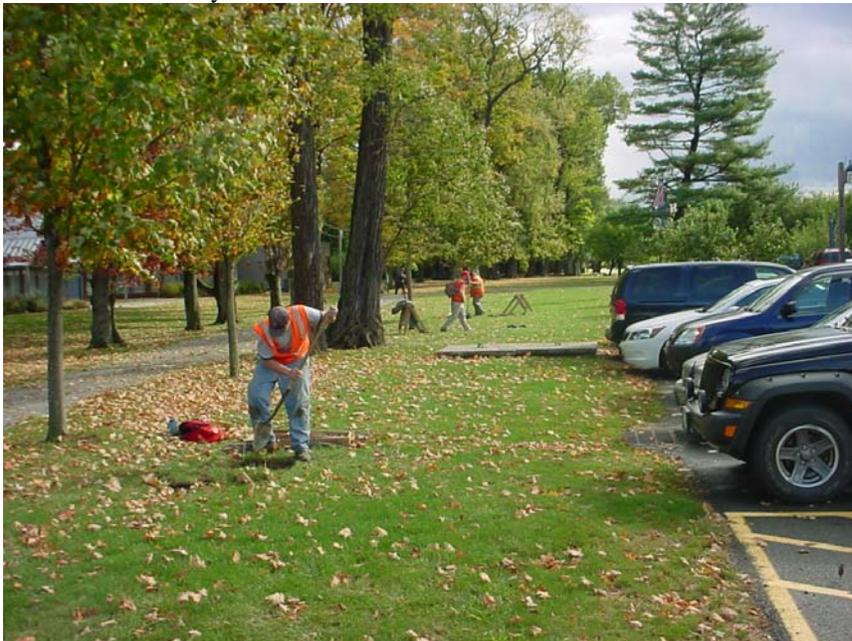
Photo 4. View east along the northern border of the library property (NARA), the employee parking area is to the right and the new Wallace Center to the left. Test 105 is being excavated by an archeologist in the foreground, to the rear the top a buried concrete electrical vault can be seen.

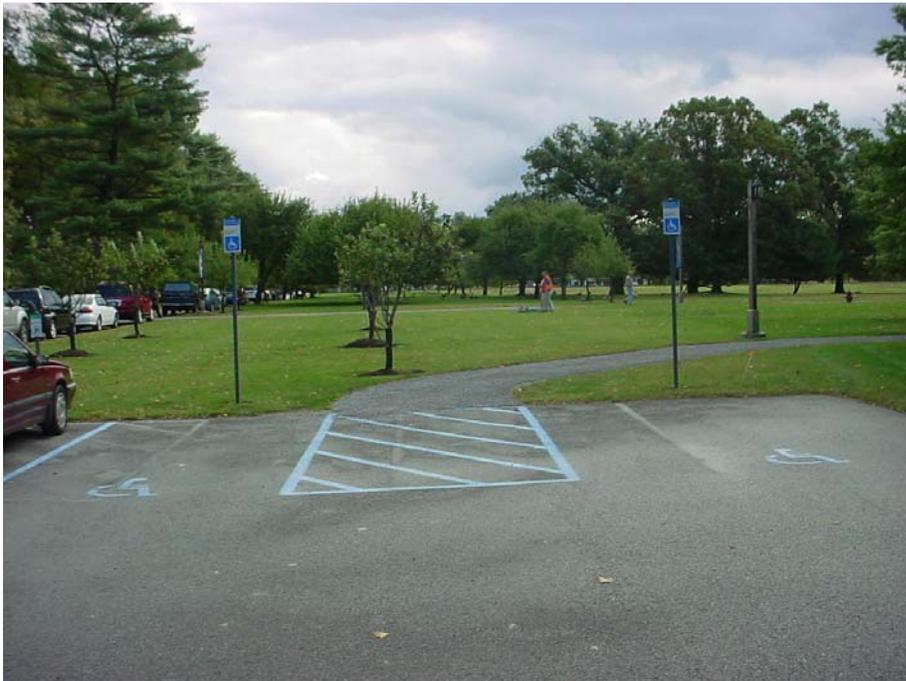
Photo 5. Archeological testing along the northeast lawn of the library. Test 109 is being excavated in the rear. According to historical maps and plans this area was once paved, the prepared substrate was evidenced in Test 109.

A second cluster of tests was excavated off of the northeast corner of the library in the front lawn (Photo 5). New water lines for fire suppression, a storm water drainage system, and heating and cooling pipes are proposed in this area. Currently, this portion of the project area is criss-crossed with existing buried utilities including water lines, sewer lines, cable and telephone lines, and electrical lines for lighting along with associated concrete vaults. Also, according to the as-built plans this area in the northeast corner of the library was originally the visitor's parking area. The parking area was subsequently removed and several manifestations of pedestrian trails were built and removed over time.

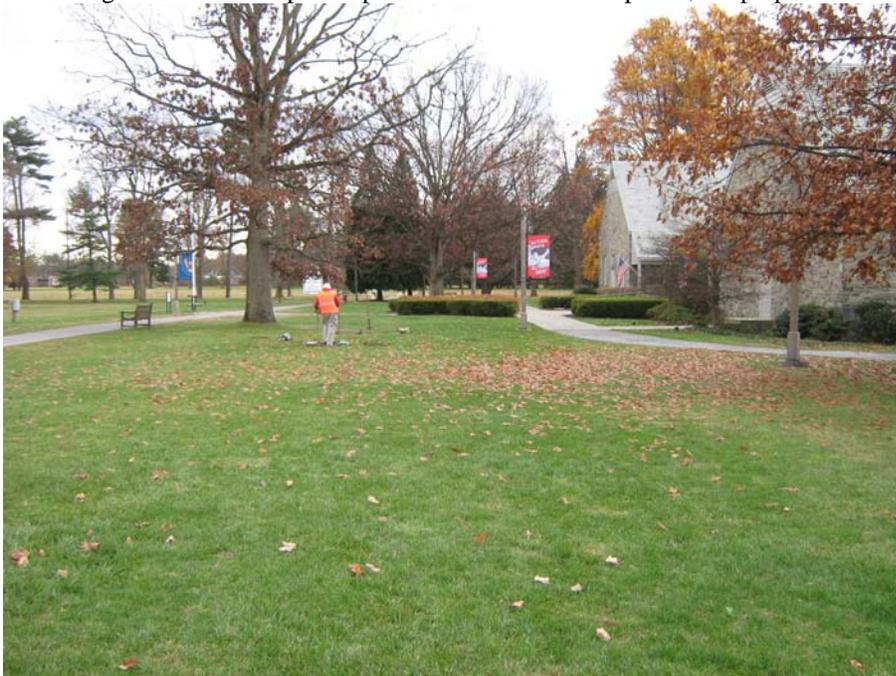
Photo 6. An archeologist excavates Test 145 along the front lawn of the FDR library. A cluster of confirmation tests helped to confirm that creamware and pearlware located in Test 113 was recovered from fill deposits, as this area evidenced extensive disturbance from buried utilities.

Test 113 evidenced three stratigraphic levels, a fill topsoil devoid of artifacts, a second fill level with a scatter of historic material, and a sterile subsoil. The second fill level had a small assemblage of two small fragments of creamware, two pearlware fragments that include a base sherd with an impressed mark "...shire" likely for the place of manufacture: Staffordshire, England which was the center of British ceramic production. In the same stratigraphic level was a brick fragment and a circa 2000 US penny. The undisturbed subsoil was found at 45 cm below the surface.

To confirm that the material was recovered from a disturbed context four additional shovel tests (143-146) were excavated at the cardinal directions at 2.5 meters from Test 113 (Photo 6). Tests 143 encounter a buried utility trench as demarked by a caution tape found at a depth of 38 cm below the surface. This may be buried cable and telecommunication cables. Test 144 also encountered a utility trench in the northern half of the test. In the southern half, the three strata were encountered. The upper stratum appeared to be modern topsoil, the middle strata fill deposits, and immediately below appeared to be undisturbed sterile subsoil with glacial silt and gravel (40 cm below surface). The utility trench cut through all three strata suggesting it was of very recent origin. The trench fill was a uniform sand and silt, with gravel fill, likely brought in from off the property.

The creamware and pearlware appear to have been part of a fill deposit. Similar scatters of late 18th and early 19th-century material were located on the nearby Bellefield property for archeology of the Wallace Center by Linck in 1983 and later Mead and Penalva (NPS 2000). This suggests that soils from other parts of the property may have been brought to the library over the course of the past 70 years. The confirmation tests indicate the area has been extensively disturbed with buried utilities. But the test also indicated that intact soil strata should have been found at a depth of less than 40 cm below the current surface where sterile subsoil was discovered in Test 144.

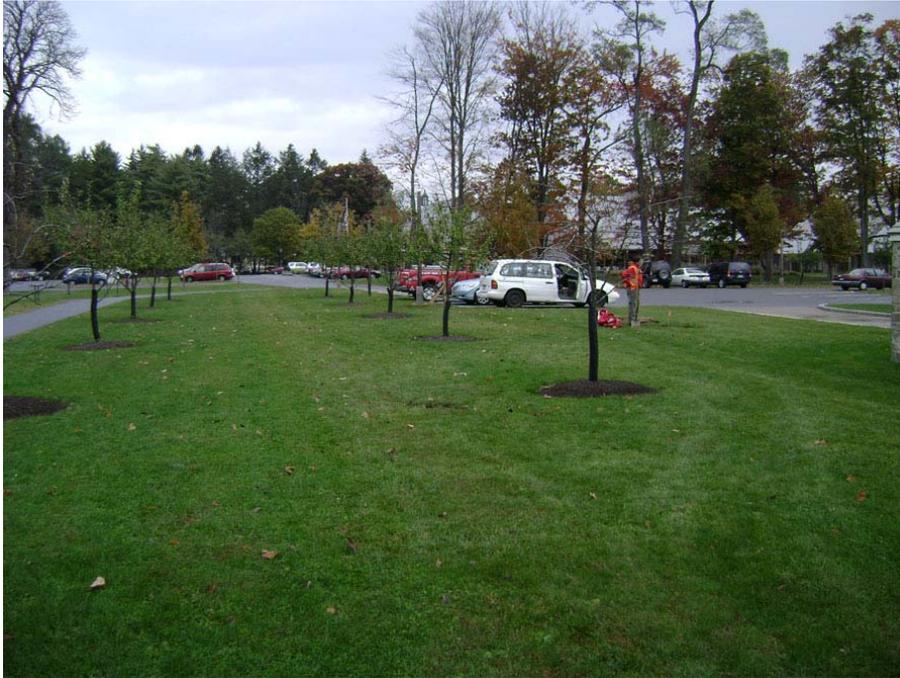
Photo 7. View north of an archeologist testing along the rear of the library. Test 128 is being excavated in the background.

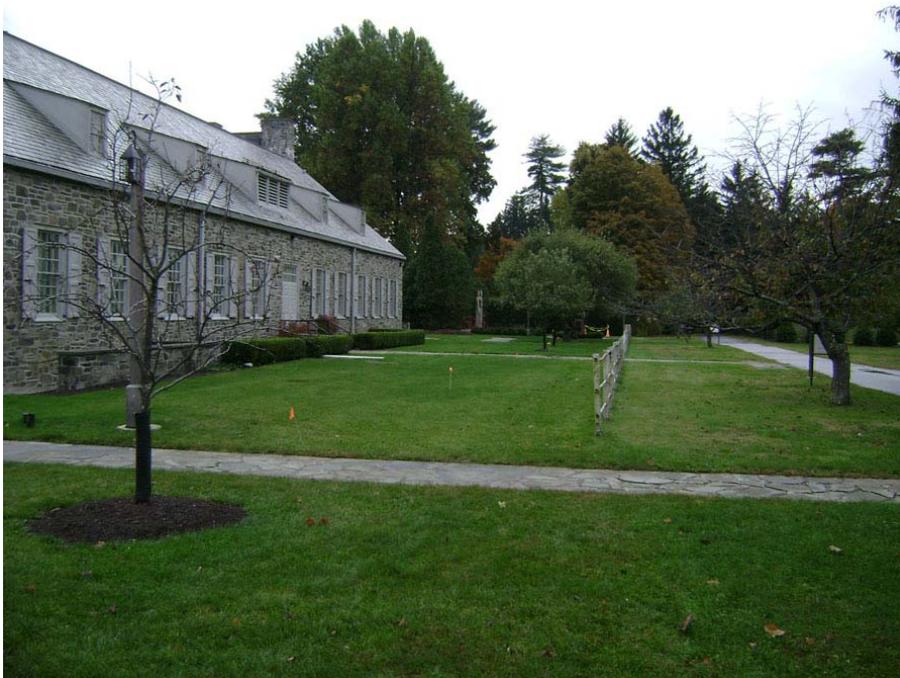
Photo 8. View southeast of the tests along the rear of the library, Test 131 is in the foreground.

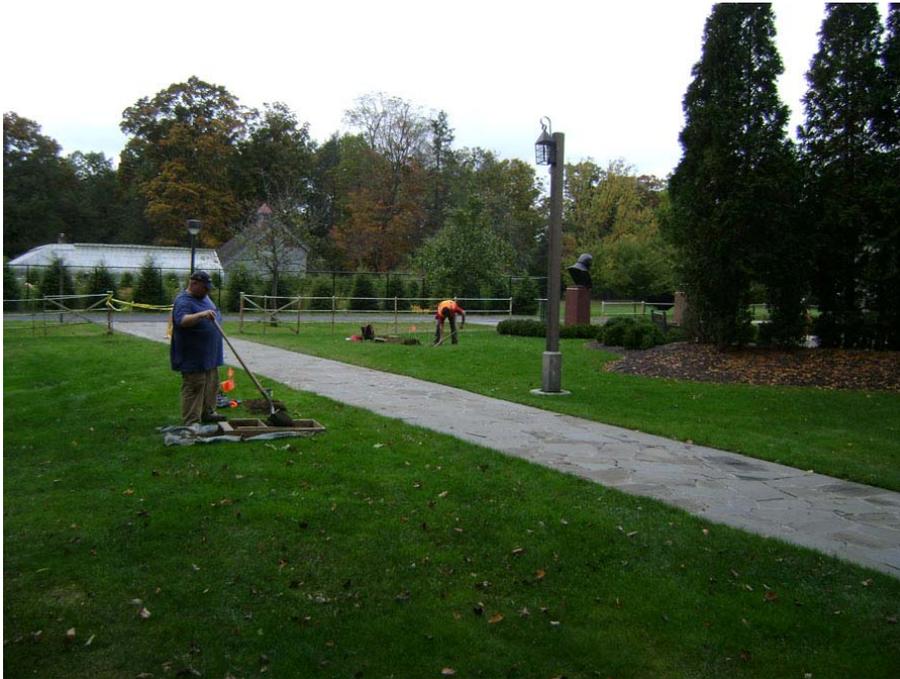
Photo 9. Archeologists excavating tests along the southern end of the library. Test 138 is in the foreground and Test 137 in the rear.
