**PHASE IB
ARCHEOLOGICAL FIELD RECONNAISSANCE**

**FDR LIBRARY AND MUSEUM IMPROVEMENT PROJECT
HOME OF FRANKLIN ROOSEVELT NATIONAL HISTORIC SITE
NATIONAL PARK SERVICE
AND
NATIONAL ARCHIVES AND RECORDS ADMINISTRATION
PROPERTY
4079 ALBANY POST ROAD
TOWN OF HYDE PARK, DUTCHESS COUNTY, NEW YORK**

**OPRHP # 09PR04334
HAA 4213-21**

Date of Report: November 2009

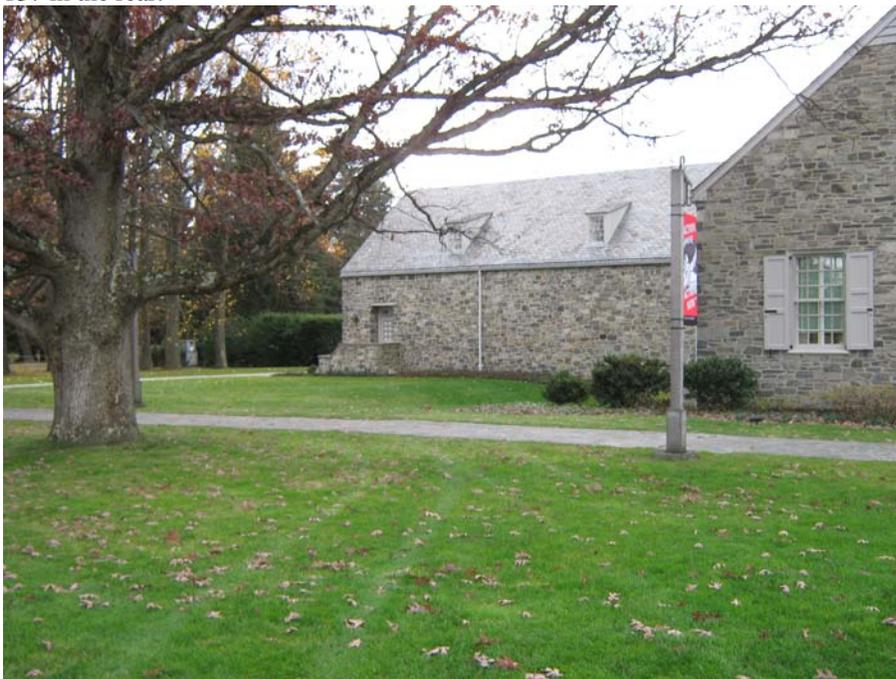
Photo 10. View southwest of the former sunken courtyard at the library. Most of the courtyard was filled in for the library additions built in 1971. The courtyard was artificial and constructed by excavating the south end of the original library.

A short transect of tests were excavated along the southeast part of the library, in what was once part of the sunken court or garden (Photo 10). Tests 141 and 142 did not encountered subsoil, as it was likely fill brought in later to level out the former sunken garden. The proposed impacts to the area include a new storm water drain and the replacement of drains around the perimeter of the foundation.

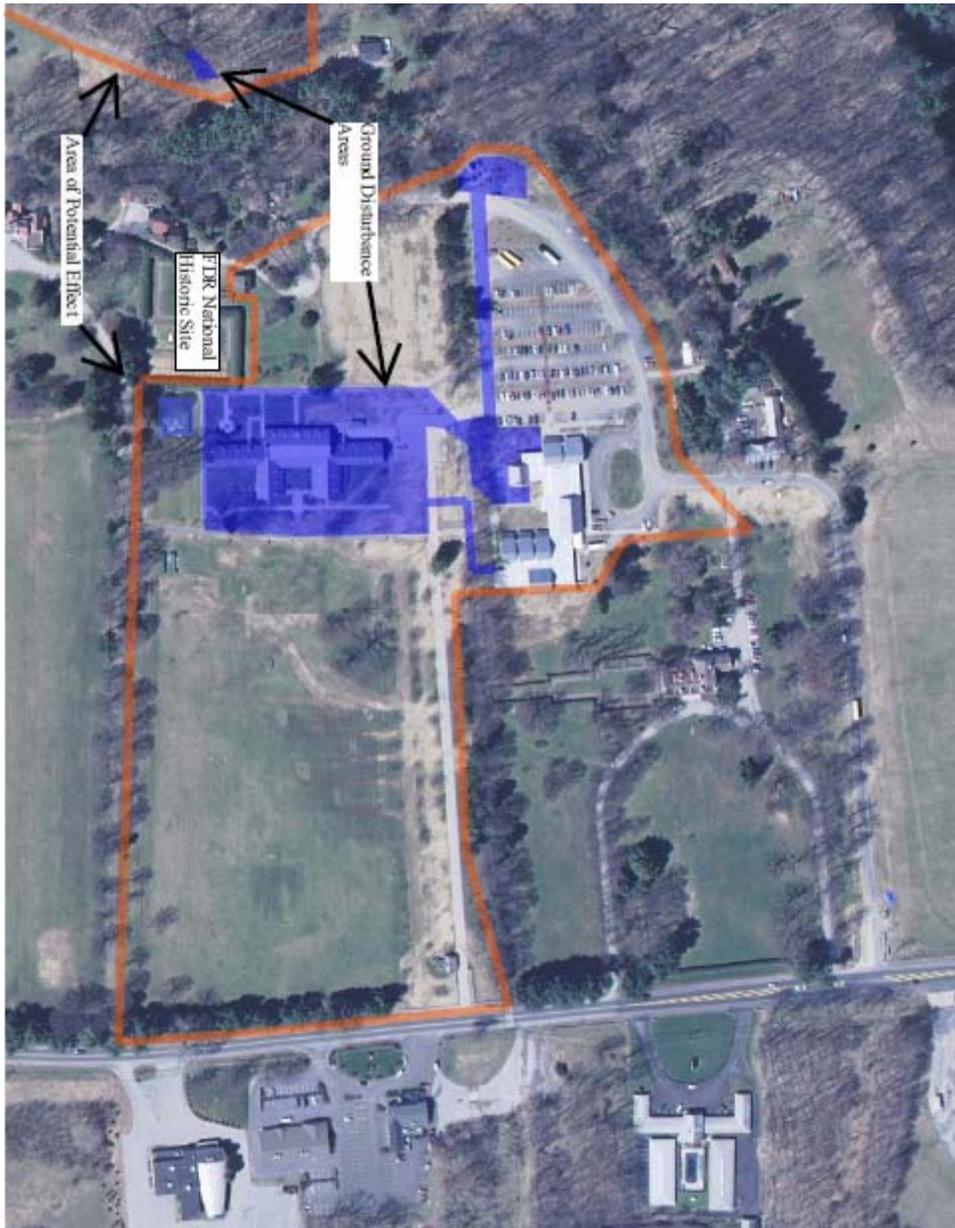
Figure 1. A summary of the area of potential effects (APE) and the proposed ground disturbing areas for the FDR library improvement project.

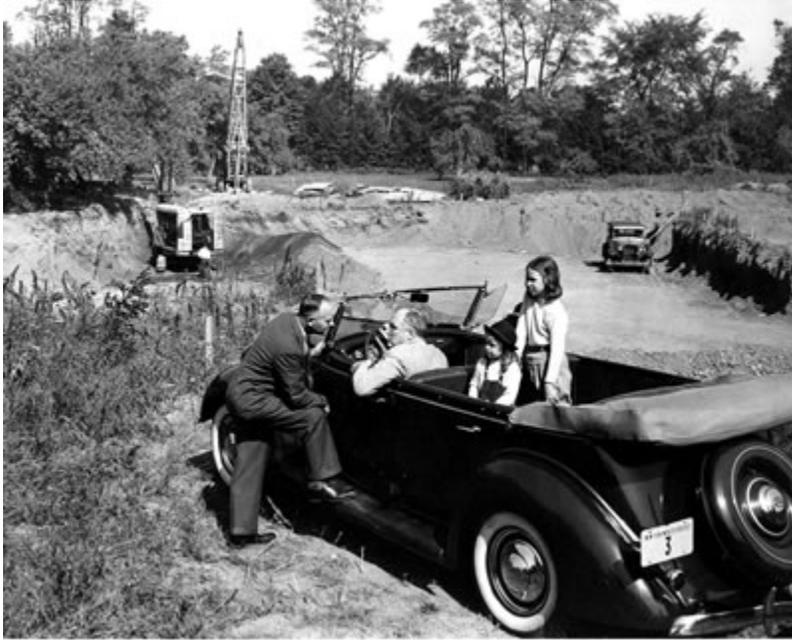
Figure 2. A circa 1939 view of the construction of the Presidential Library, as supervised by Franklin Roosevelt. Note the truck in the excavation for what would become the cellar of the library. The view is to the northwest. The archeology revealed widespread disturbances around the library from initial construction, later additions and upgrades to the library (<http://docs.fdrlibrary.marist.edu/frdcsb10.html>).
